# Biological Assessment and Evaluation Access Design for Highway 84 at Mill Creek Road Project (CDOT Permit #517018)

Mountain Crossing LLC,  
c/o Summit AE  
2764 Compass Drive, Suite 230  
Grand Junction, CO 81506

Ecosphere Environmental Services, Inc.  
776 E. Second Avenue  
Durango, CO 81301  
(970) 382-7256

# Pagosa Skyrocket Survey Report

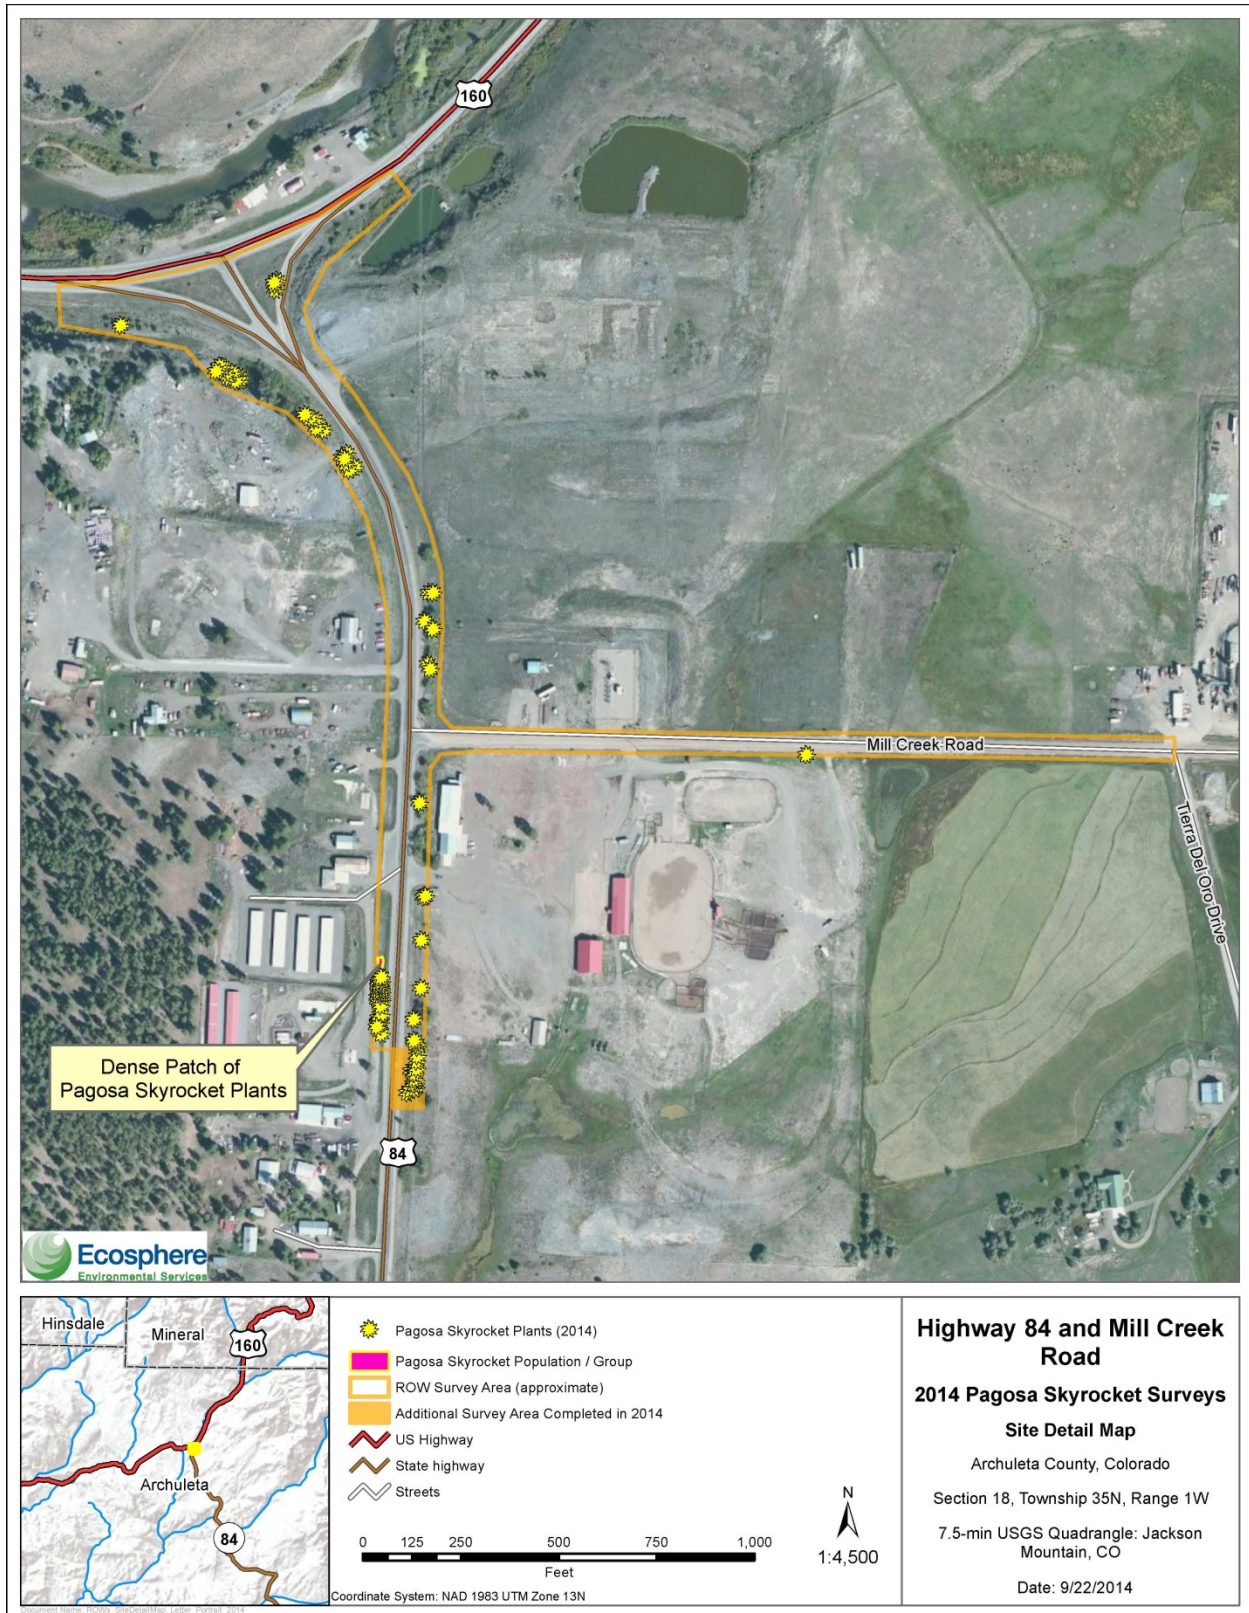
**Figure 3. 2014 Survey Results – Pagosa Skyrocket Plants within the Survey Area**

During the 2014 survey effort, approximately 1,822 Pagosa skyrocket plants were observed within the survey area, including 501 flowering plants (adults) and 1,321 rosettes. Plants were scattered throughout the survey area similarly to the 2013 plant locations, as shown on Figure 3 (Appendix A). There was an overall increase in the number of plants observed in the survey area; however, some of the increase (55 adults and 135 rosettes) can be attributed to the additional survey area that was completed in 2014 along the eastern ROW of Hwy 84.

As in 2013, the majority of plants were observed along Hwy 84 (496 adults and 1,320 rosettes). There was a reduction in the number of occurrences on Mill Creek Road (one occurrence in 2014 vs. 3 occurrences in 2013); however, the number of plants was relatively similar (5 adults and 1 rosette). The dense patch of plants on the west side of Hwy 84 near Mountain View Storage was again observed, with approximately 210 adults (42 percent of total adults observed) and 280 rosettes (21 percent of total rosettes observed). As a note, portions of the highway ROW were apparently mowed in late June or early July 2014, just before surveys were completed. The mowing may have affected the ability to detect adults and rosettes. Adult plants may have been inadvertently excluded from the count due to the removal of the plant stalk and flowers. In addition, rosettes may have been more visible than in previous surveys due to the removal of tall grasses and herbaceous overstory.

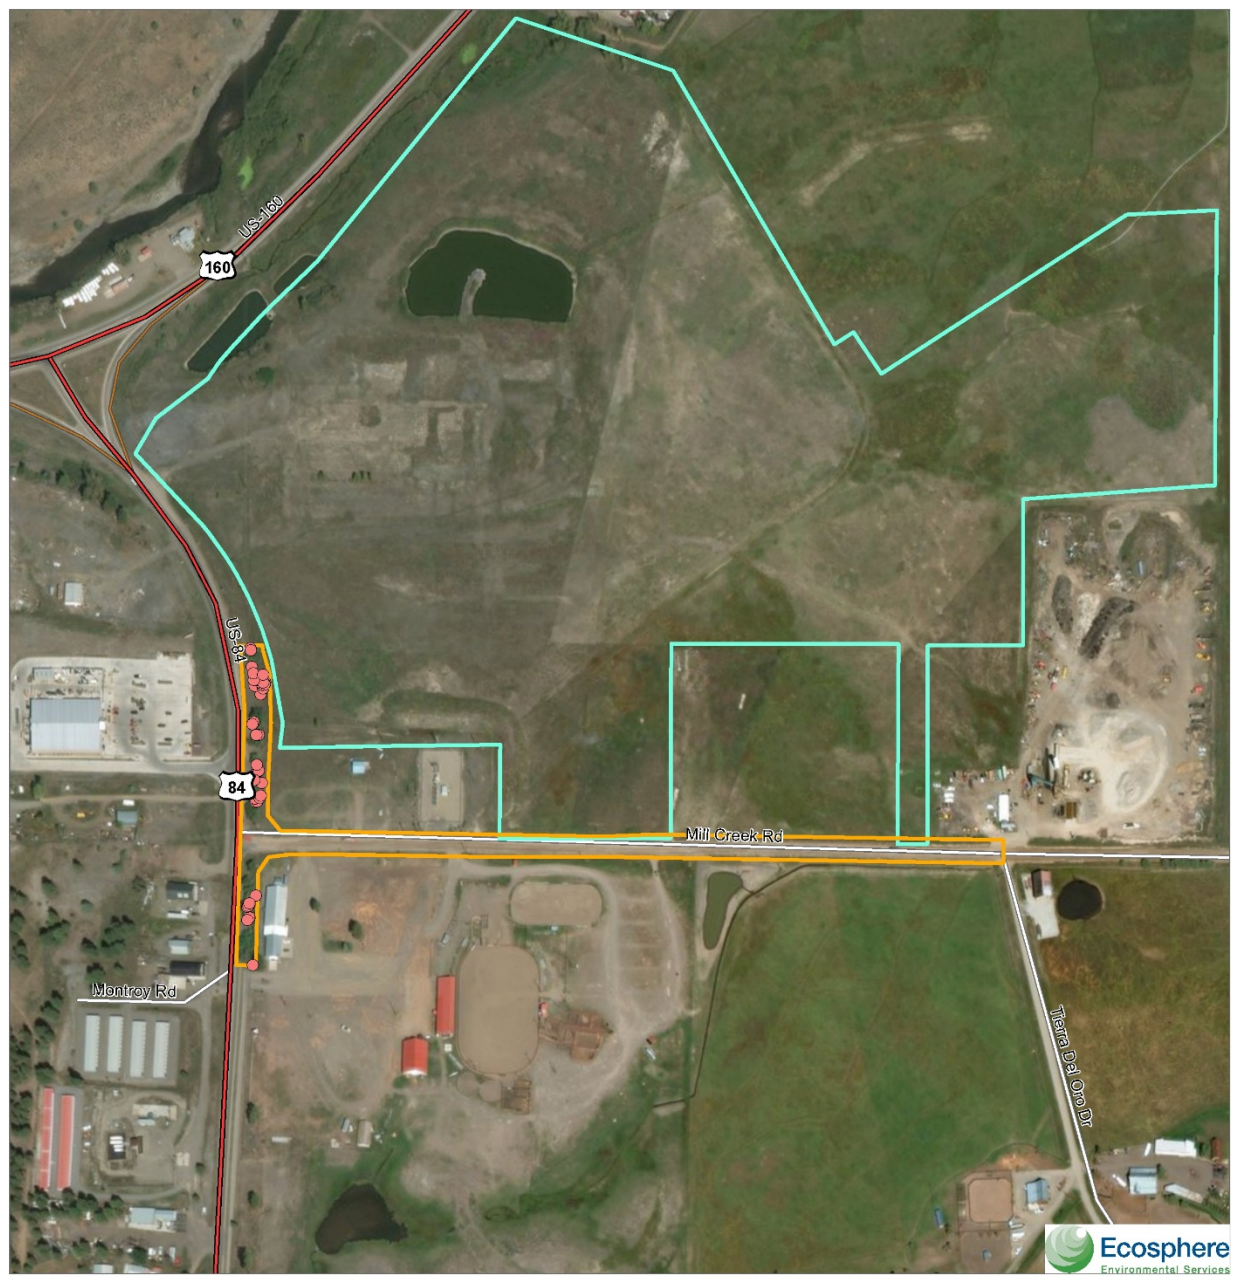
**Figure 6. 2017 Survey Results – Pagosa Skyrocket Plants within the Survey Area**

Approximately 321 Pagosa skyrocket plants were observed within the 2017 survey area, including 133 flowering plants (adults) and 188 rosettes. Plants were observed scattered throughout the survey area similar to previous years, as shown on Figure 6 (Appendix A). The 2017 surveys were completed across the same area that was surveyed in 2016, covering approximately 3.6 acres (Figure 7, Appendix A).

Similar to previous surveys, the majority of plants were observed along Hwy 84 (130 adults and 188 rosettes). As in previous years, a small cluster of plants was observed on Mill Creek Road. The Mill Creek Road occurrence was limited to 3 adults; no rosettes were observed. Casual observation of the western side of the Highway 84 ROW indicated that the area is still occupied by Pagosa skyrocket; however, the western side of the Highway 84 ROW was not surveyed in 2017.

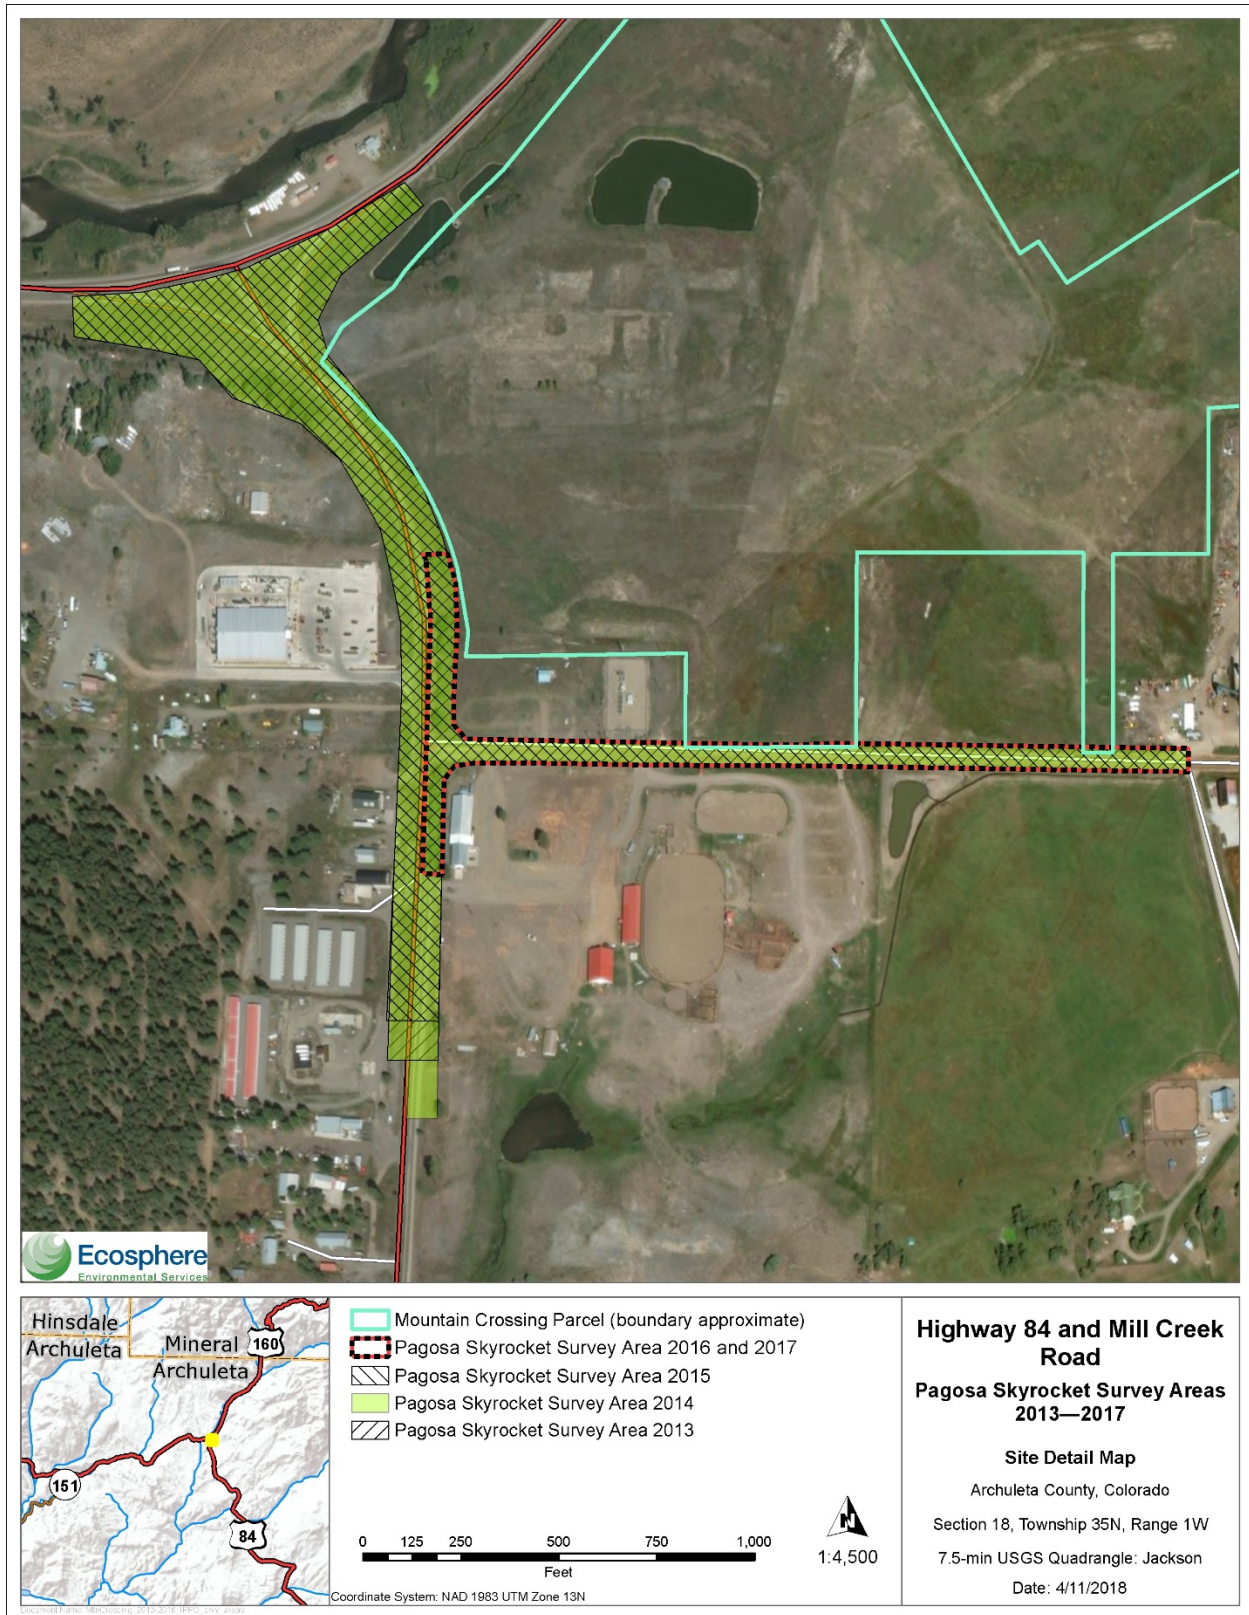
**Figure 7. Pagosa Skyrocket Survey Area Boundaries, 2013 – 2017**

Approximately 202 Pagosa skyrocket plants were observed within the 2016 survey area, including 79 flowering plants (adults) and 123 rosettes. Plants were observed scattered throughout the survey area similar to previous years, as shown on Figure 5 (Appendix A). In order to reflect changes in project design, the 2016 survey area was reduced from approximately 12.1 acres to approximately 3.6 acres (Figure 7, Appendix A).

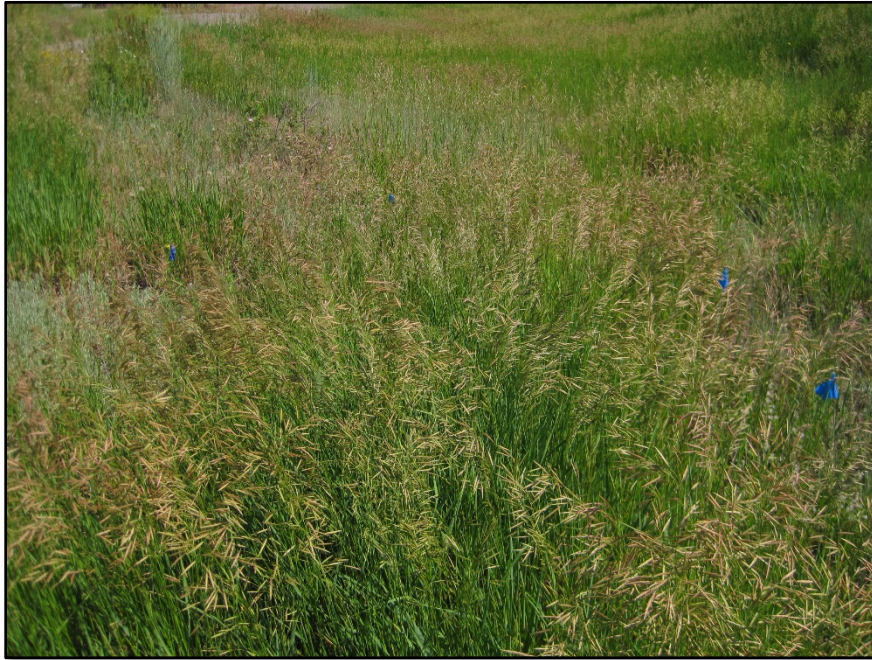
**Photo 3. Dense vegetation and tall grass observed during 2015 surveys; Pagosa skyrocket individuals are marked with blue flags**

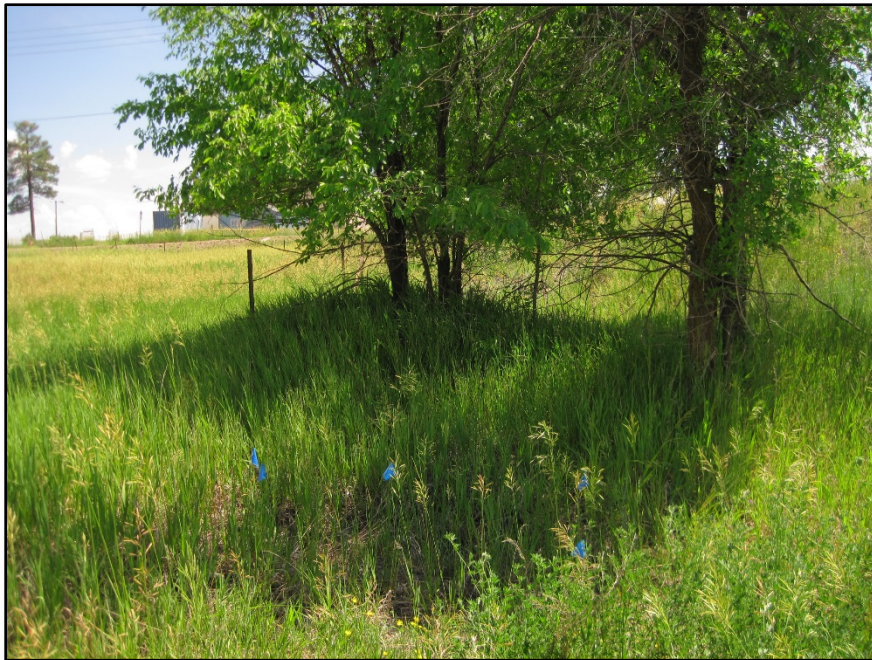
**Photo 4. Pagosa skyrocket individuals growing in the shade of Siberian elm trees on the east side of Highway 84 during 2015 surveys**

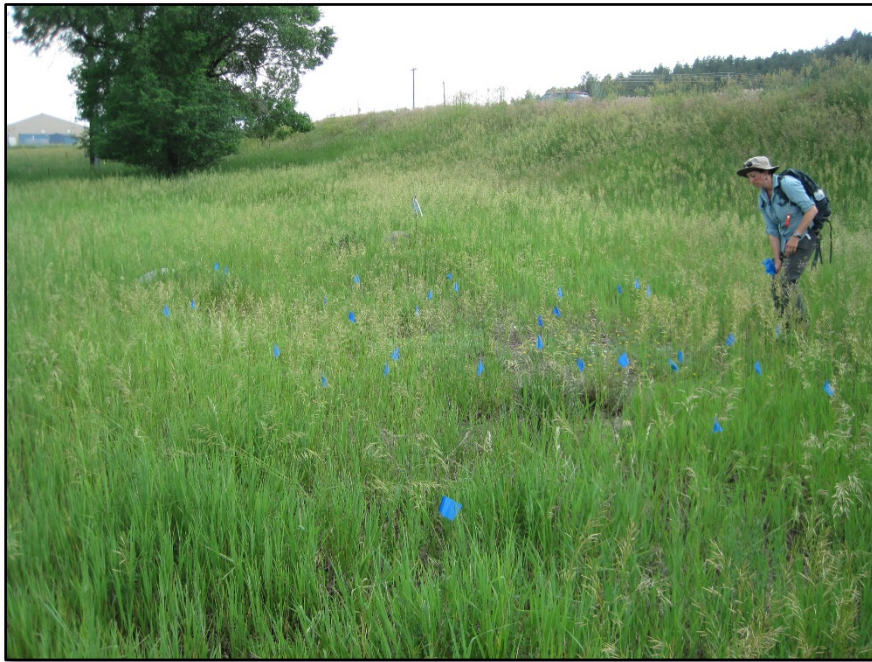
**Photo 5. Dense grasses observed on the east side of Highway 84 during 2015 surveys. Pagosa skyrocket individuals are marked with blue flags**

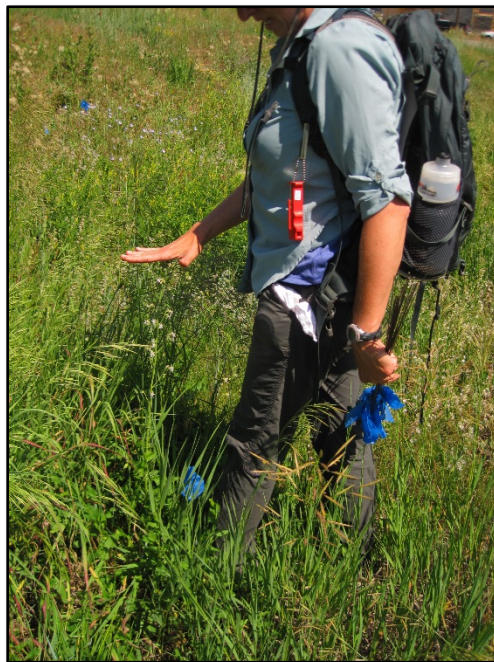
**Photo 6. Exceptionally tall Pagosa skyrocket observed in 2015 competing with smooth brome in dense skyrocket patch at southwest end of Hwy 84 survey area**
